B214ST Field Repair

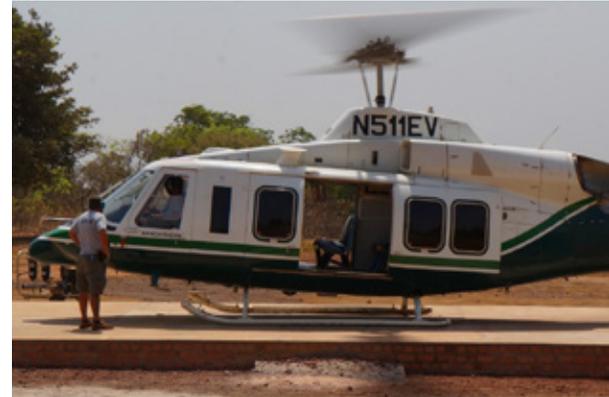
A routine field inspection revealed a crack in the engine deck – likely due to regular flight vibration – the aircraft was grounded, and Erickson's crew of mechanicals was put into action. A repair of this nature would typically require mobilizing the aircraft to a certified maintenance center, where it could be dismantled in a secured hangar and lifted into an aircraft jig. Yet, while working in rugged and distant environments, down time on a critical flight schedule is not an option. Accordingly, Erickson crews are regularly equipped for repairs in the field.

In this situation, the mechanical team communicated with Erickson's stateside operations to engineer a mobile aircraft jig that could keep the frame aligned during repair. Engineers within Erickson's Manufacturing and MRO facilities replicated the hangar's permanent, full-size jig, into something that could be broken down and transported halfway around the globe. The result, thanks to Erickson's global supply chain and logistical support, allowed mechanics in the field to reassemble the jig, and repair the aircraft properly.
